Breast Implant Imaging

N.Sadighi
TUMS
ADIR

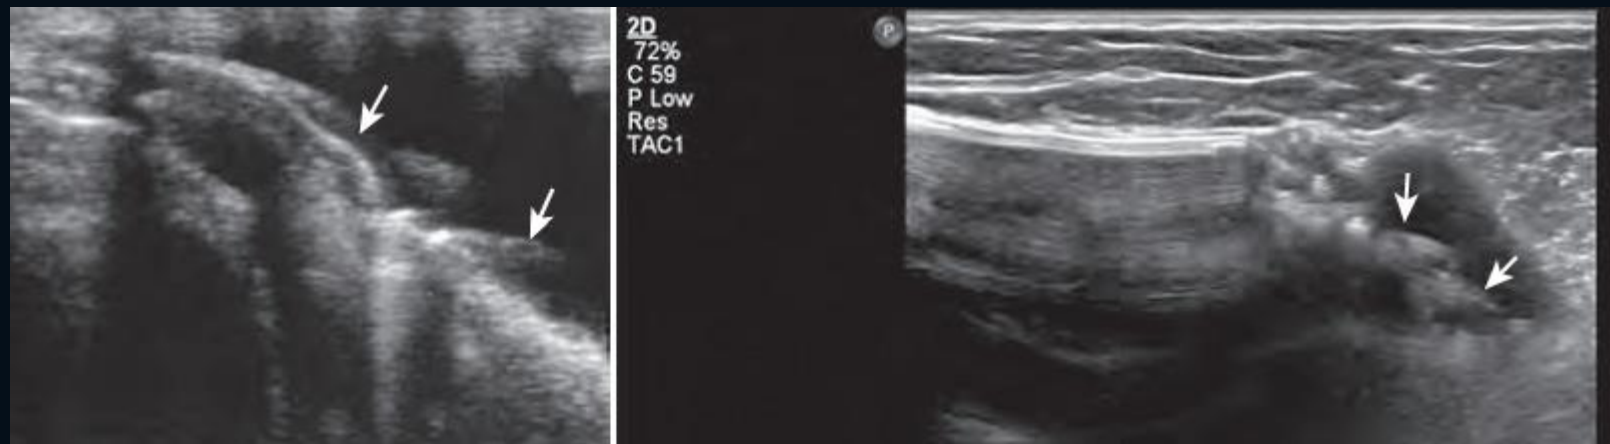
False positive of stepladder sign in multi-lumen implant

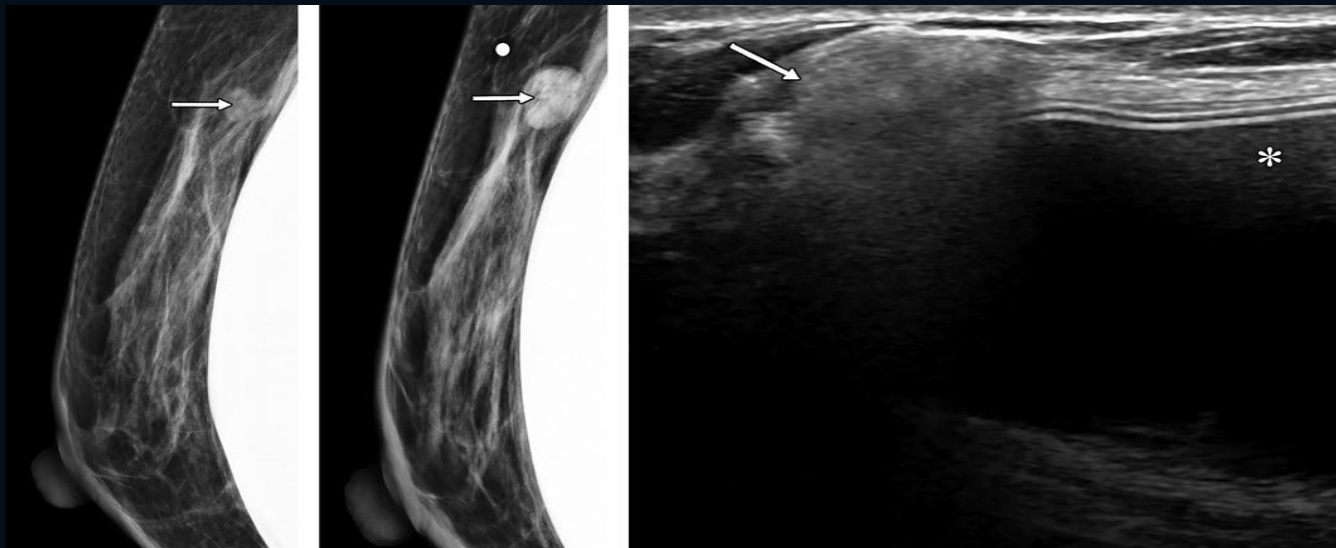
Right MLO mammogram demonstrates an oval isodense mass (arrow) adjacent to the implant.

Enlargement and increased density of the mass 3 years later (arrow)

US reveals **snowstorm** within an intra-mammary lymph node (arrow) due to extracapsular silicone. The implant is anechoic with normal configuration of the shell-capsular complex, indicating an intact implant.
